CHICAGO DOE

FORMER INGERSOLL PRODUCTS
1000 West 120th Street
Chicago, Illinois 60643

SUMMARY OF
PHASE I ESA FINDINGS -
EASTERN PORTION

FIGURE NO.
6

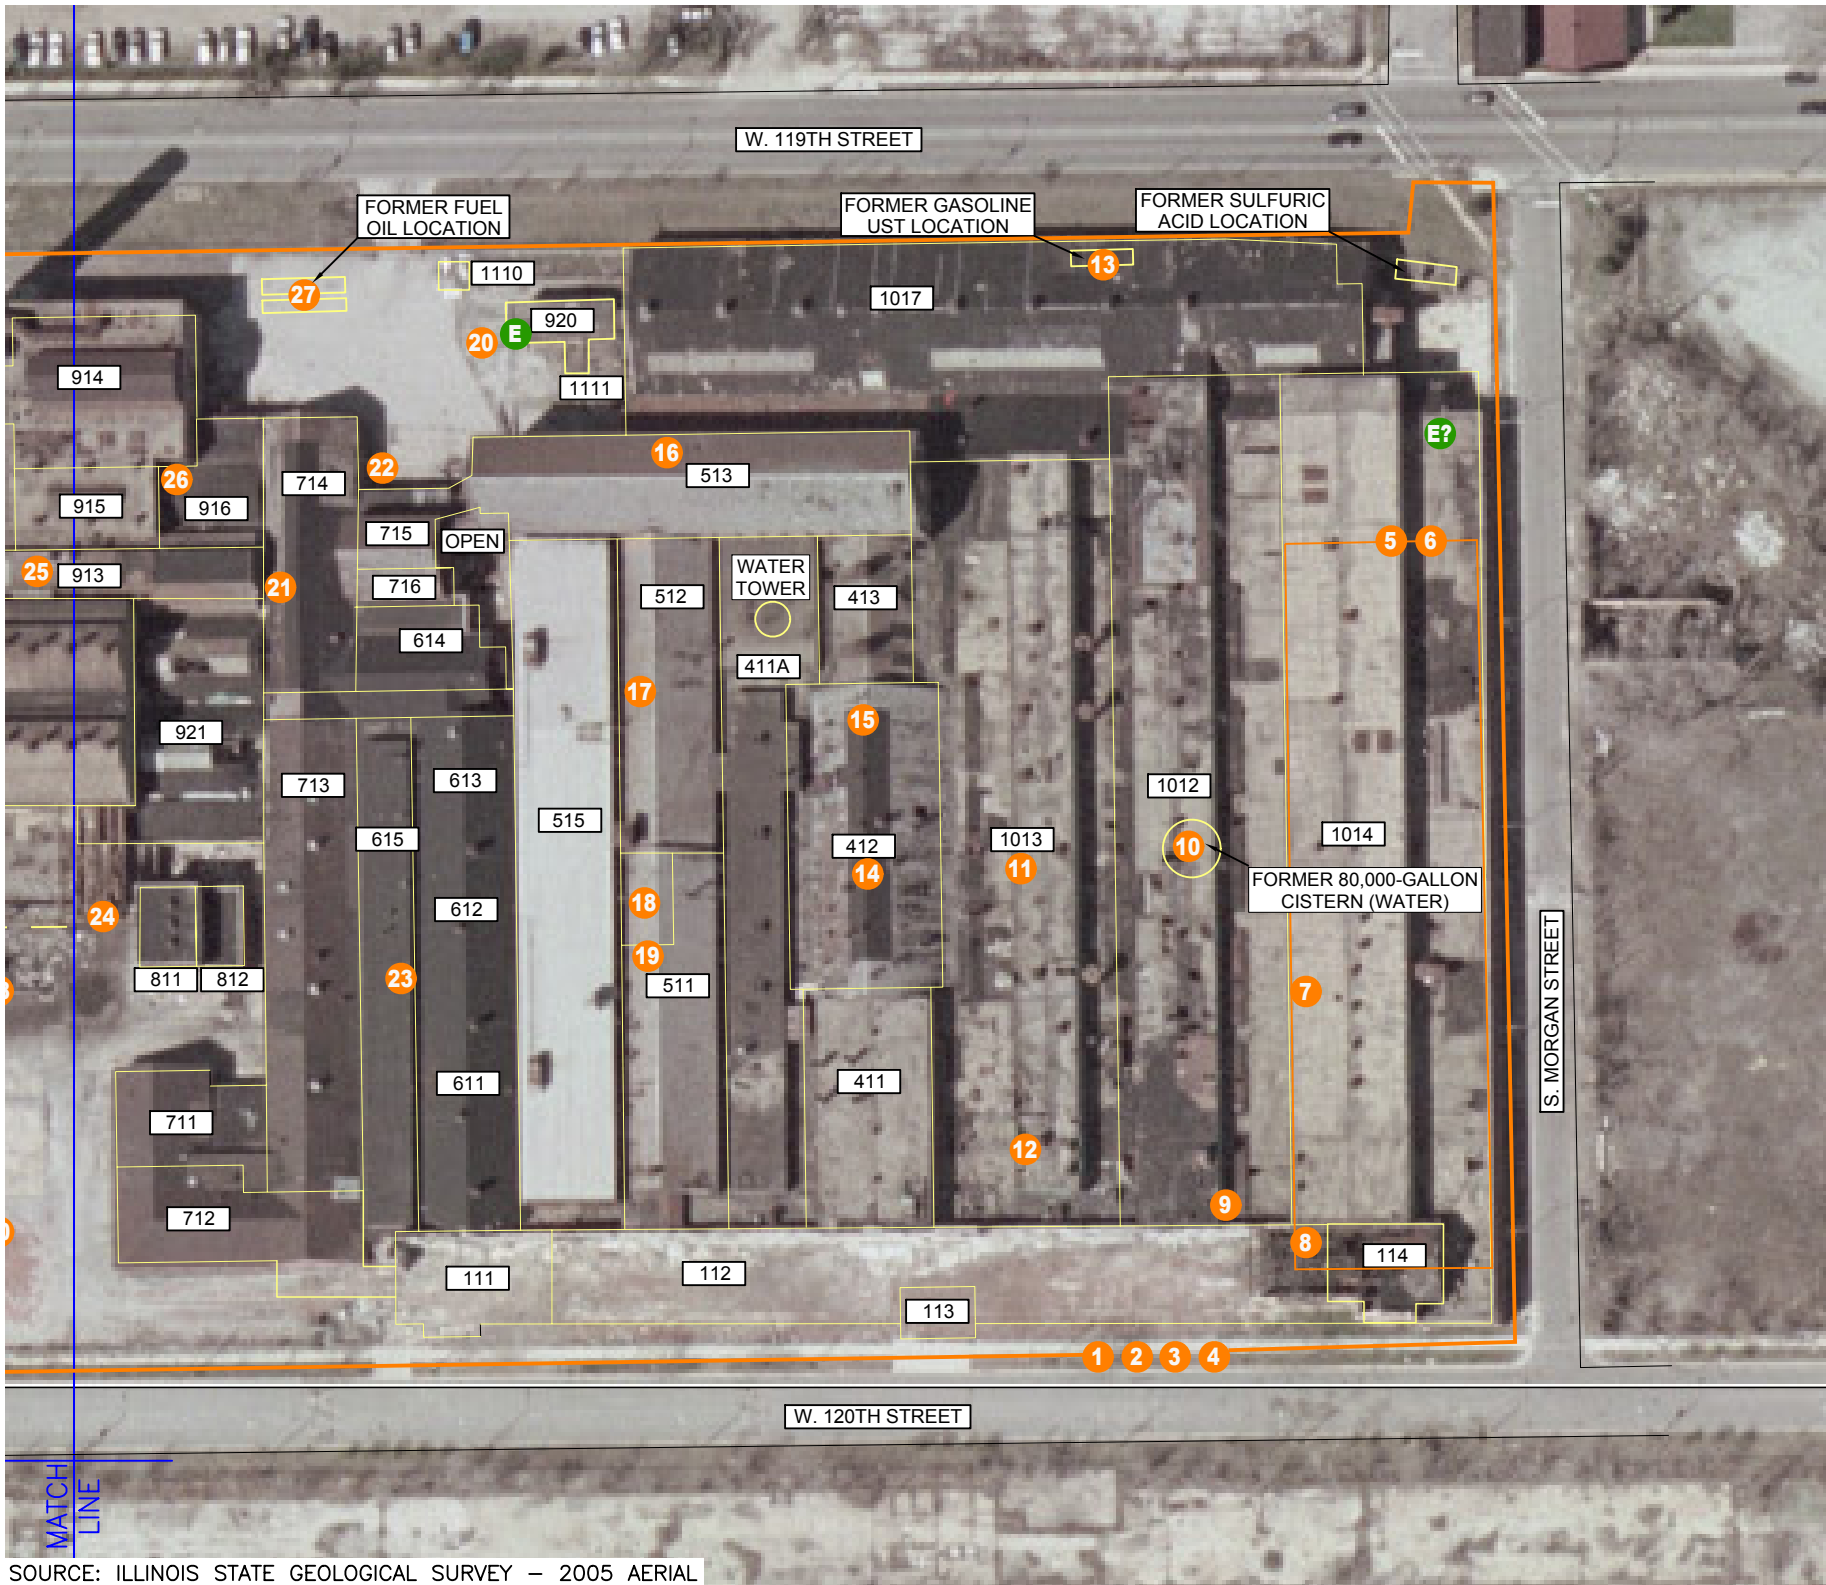
REC #	ADDRESS / LOCATION PARCEL # / CSM	ISSUE/CONCERN
1	GENERAL PROPERTY	HYDROCARBON AFFECTED SOIL REMAINS IN-PLACE (SITE-WIDE IN A NON-UNIFORM MANNER) ACROSS THE SUBJECT PROPERTY EXTENDING TO DEPTHS OF 0 TO 11 FT BGS. THIS CONDITION ALSO REPRESENTS A VAPOR ENCRUSTMENT CONDITION ON THE SUBJECT PROPERTY. FREE-PRODUCT ALSO REMAINS IN-PLACE IN SELECT AREAS (BLDG 412, BLDG 924 AND LIKELY BLDG 920) ON THE SUBJECT PROPERTY.
2	GENERAL PROPERTY	DISCREPANCIES EXIST BETWEEN THE NUMBER OF USTS REGISTERED AND/OR PERMITTED AND THE NUMBER OF USTS IDENTIFIED AND SUBJECTED TO U.S. EPA TIME-CRITICAL REMOVAL ACTIONS. AS SUCH, UNREMOVED AND UNPERMITTED MAY REMAIN IN-PLACE THROUGHOUT THE SUBJECT PROPERTY. IT SHOULD BE NOTED THAT USTS SUBJECT TO U.S. EPA TIME-CRITICAL ACTIONS WERE VACATED OF PRODUCT, DECONTAMINATED, BACKFILLED, AND ABANDON IN-PLACE.
3	GENERAL PROPERTY	PRESENCE OF FORMER HEAVY INDUSTRIAL OPERATIONS FROM ABOUT 1893 THROUGH THE MID 1990S WITH THE STORAGE, USE AND MANAGEMENT OF PETROLEUM PRODUCTS AND HAZARDOUS SUBSTANCES. VARIOUS MANUFACTURING PROCESS LINES AND FUNCTIONAL AREAS LIKELY DISCHARGED TO FLOOR DRAINS, SUMPS, BELOW-GRADE COLLECTION AND/OR RECIRCULATION SYSTEMS. AN EVALUATION OF THE INTEGRITY OF THE COLLECTION SYSTEMS, CONCRETE CONTAINMENT AND SEWAGE PIPELINE SYSTEM IS BEYOND THE SCOPE OF THIS ASSESSMENT. U.S. EPA TIME-CRITICAL ACTIONS INCLUDED THE PRESSURE WASHING, DEGREASING, DECONTAMINATING AND DETERTERING OF NUMEROUS, BUT POTENTIALLY NOT ALL, BELOW-GRADE FEATURES AND COLLECTION SYSTEMS. THE UNKNOWN DISTRIBUTION LAYOUT, AGE AND UNKNOWN INTEGRITY OF THE BELOW-GRADE FEATURES AND COLLECTION SYSTEMS IS A CONDITION FOR WHICH SHAW CANNOT ELIMINATE THE POTENTIAL FOR RELEASE TO HAVE IMPACTED THE SUBJECT PROPERTY.

4	GENERAL PROPERTY	BASED ON THE URBAN SETTING OF THE SUBJECT PROPERTY, FORMER DEVELOPMENT, DEMOLITION, AND PLACEMENT OF FILL ON THE SUBJECT PROPERTY, ALONG WITH SHAW'S EXPERIENCE WITH SIMILAR SITES IN THE REGION, A POTENTIAL EXISTS FOR THE URBAN SOIL/FILL TO CONTAIN POLYNUCLEAR AROMATIC HYDROCARBONS, TOTAL LEAD AND ARSENIC CONSTITUENT CONCENTRATIONS AT LEVELS ABOVE REGULATORY INGESTION EXPOSURE ROUTE STANDARDS.
5	BLDG 1014	RESIDUAL PCB-CONTAMINATED CONCRETE AT CONCENTRATIONS WHICH ARE CLASSIFIED AS TSCA 'RESTRICTED AREA'. REMAINS IN-PLACE THROUGHOUT BLDG 1014 AND IS ENCAPSULATED BENEATH GREY EPOXY PAINT. THIS CONDITION MEETS THE CRITERIA OF A HREC. HOWEVER, CONSIDERING THE CONTEMPLATION OF FUTURE REDEVELOPMENT AND THE UNKNOWN REDEVELOPMENT PLAN, SHAW ELEVATES THIS TO A REC.
6	BLDG 1014	RESIDUAL PCB-CONTAMINATED SOIL ABOVE ILLINOIS TACO TIER 1 COMMERCIAL/INDUSTRIAL INGESTION REMEDIAL OBJECTIVE REMAINS IN-PLACE (WESTON 2007, B168) BENEATH THE FORMER MACHINE PAD (NORTHEAST AREA) AND BENEATH MOST OF BLDG 1014. THE EXISTING CONCRETE FLOOR SLAB HAS BECOME AN 'ENGINEERING BARRIER' RELATIVE TO THE RESIDUAL PCB-CONTAMINATED SOIL WHICH REMAINS IN-PLACE.

7	BLDG 1014	LEAD CONTAMINATED SOIL ABOVE ILLINOIS TACO TIER 1 COMMERCIAL/INDUSTRIAL INGESTION REMEDIAL OBJECTIVE REMAINS IN PLACE (WESTON 2007, B168) EXTENDING TO DEPTHS OF 1 TO 6 FT.
8	BLDG 112	RESIDUAL PCB-CONTAMINATED CONCRETE AT CONCENTRATIONS WHICH ARE SUBJECT TO TSCA REGULATIONS (FORMER TRANSFORMER SUBSTATION 13, BLDG 112) REMAINS IN-PLACE AND IS ENCAPSULATED BENEATH GREY EPOXY PAINT. THIS CONDITION MEETS THE CRITERIA OF A HREC. HOWEVER, CONSIDERING THE CONTEMPLATION OF FUTURE REDEVELOPMENT AND THE UNKNOWN REDEVELOPMENT PLAN, SHAW ELEVATES THIS TO A REC.
9	BLDG 1012	RESIDUAL PCB-CONTAMINATED CONCRETE AT CONCENTRATIONS WHICH ARE SUBJECT TO TSCA REGULATIONS (FORMER TRANSFORMER SUBSTATION 12, BLDG 1012) REMAINS IN-PLACE AND IS ENCAPSULATED BENEATH GREY EPOXY PAINT. THIS CONDITION MEETS THE CRITERIA OF A HREC. HOWEVER, CONSIDERING THE CONTEMPLATION OF FUTURE REDEVELOPMENT AND THE UNKNOWN REDEVELOPMENT PLAN, SHAW ELEVATES THIS TO A REC.

10	BLDG 1012	THE 1897 - 1911 SANBORN FIRE INSURANCE MAPS ILLUSTRATE THE PRESENCE OF AN 80,000-GALLON CISTERN 'FILLED WITH CITY WATER' IN THE EAST-CENTRAL AREA OF BLDG 1012. NO SPECIFIC OR DIRECT REFERENCE TO THIS CISTERN 'PIT' IN THE DESIGNATED BUILDING AREA) RELATIVE TO THE IDENTIFICATION, ASSESSMENT (PRESENCE/ABSENCE OF LIQUID OR PRODUCT), AND COMPLETION OF U.S. EPA TIME-CRITICAL REMOVAL OR DECONTAMINATION ACTIONS WAS AVAILABLE.
11	BLDG 1013	THE 1950 - 2004 SANBORN FIRE INSURANCE MAPS ILLUSTRATE THE PRESENCE OF A 'VITREOUS ENAMELING' AREA AND OTHER REPORTS REFERENCE SPRAY BOTH OPERATIONS IN BLDG 1013. BASED ON SHAW'S EXPERIENCE WITH THESE OPERATIONAL AREAS HAZARDOUS SUBSTANCES (SOLVENTS WITH VOCs, CVOCs) ARE TYPICALLY USED. THERE IS A LACK OF QUALITATIVE SOIL AND/OR GROUNDWATER DATA AVAILABLE WITHIN THIS GENERAL AREA (BLDG 1013) WITH RESPECT TO VOC, CVOC CONSTITUENTS.
12	BLDG 1013	THE 1911 SANBORN FIRE INSURANCE MAP ILLUSTRATES THE PRESENCE OF AN OIL HOUSE IN THE SOUTH-CENTRAL END OF BLDG 1013. THERE IS A LACK OF QUALITATIVE SOIL AND/OR GROUNDWATER DATA AVAILABLE WITHIN THIS GENERAL AREA (BLDG 1013) WITH RESPECT TO PETROLEUM HYDROCARBON CONSTITUENTS.

13	BLDG 1017	THE 1911 SANBORN FIRE INSURANCE MAP ILLUSTRATES THE PRESENCE OF ONE GAS OIL UST LOCATED BENEATH BLDG 1017 (NORTH-CENTRAL AREA). IT IS UNKNOWN IF THIS UST REMAINS IN-PLACE. THERE IS A LACK OF QUALITATIVE SOIL AND/OR GROUNDWATER DATA AVAILABLE WITHIN THIS GENERAL AREA (BLDG 1017) WITH RESPECT TO THIS UST.
14	BLDG 412	THE 1939 - 2004 SANBORN FIRE INSURANCE MAPS ILLUSTRATE THE PRESENCE OF AN 'ENAMELING' AREA AND OTHER REPORTS REFERENCES SPRAY BOOTH OPERATIONS IN BLDG 412. BASED ON SHAW'S EXPERIENCE WITH THESE OPERATIONAL AREAS HAZARDOUS SUBSTANCES (SOLVENTS WITH VOCs, CVOCs) ARE TYPICALLY USED. THERE IS A LACK OF QUALITATIVE SOIL AND/OR GROUNDWATER DATA AVAILABLE WITHIN THIS GENERAL AREA (BLDG 412) WITH RESPECT TO VOC, CVOC CONSTITUENTS.
15	BLDG 412	THE WESTON FEBRUARY 2007 SITE-WIDE GEOPROBE INVESTIGATION IDENTIFIED THE PRESENCE OF FREE PRODUCT IN THE NORTHERN PORTION OF BLDG 412 (SOIL BORINGS B130, B131, AND B169). UTILIZING AVAILABLE BORING LOGS (BORING LOGS WERE NOT AVAILABLE FOR WESTON 2006 NEARBY BORINGS - B16 AND B19) THE FREE PRODUCT PLUME MAY EXTEND IN A NORTHWESTERLY DIRECTION UP TO POTENTIAL DISTANCES OF 150 TO 250 FT (THE NEXT CLOSEST AND AVAILABLE BORING LOG RECORD). THE QUALITATIVE NATURE, HORIZONTAL AND VERTICAL EXTENT OF THE FREE PRODUCT PLUME NEAR BLDG 412 HAS NOT YET BEEN FULLY DEFINED.

16	BLDG 513	THE 1975 - 2004 SANBORN FIRE INSURANCE MAPS ILLUSTRATE THE PRESENCE OF A 'DIPPING' AREA IN THE NORTH CENTRAL PORTION OF BLDG 513. BASED ON SHAW'S EXPERIENCE WITH THESE OPERATIONAL AREAS PETROLEUM AND HAZARDOUS SUBSTANCES (QUENCH OILS, SOLVENTS WITH VOCs, CVOCs) ARE TYPICALLY USED. THERE IS A LACK OF QUALITATIVE SOIL AND/OR GROUNDWATER DATA AVAILABLE WITHIN THIS GENERAL AREA (BLDG 513) WITH RESPECT TO VOC, CVOC CONSTITUENTS.
17	BLDG 512	RESIDUAL PCB-CONTAMINATED CONCRETE AT CONCENTRATIONS WHICH SUBJECT TO TSCA REGULATIONS (FORMER TRANSFORMER SUBSTATION 9, BLDG 512) REMAINS IN-PLACE AND IS ENCAPSULATED BENEATH GREY EPOXY PAINT. THIS CONDITION MEETS THE CRITERIA OF A HREC. HOWEVER, CONSIDERING THE CONTEMPLATION OF FUTURE REDEVELOPMENT AND THE UNKNOWN REDEVELOPMENT PLAN, SHAW ELEVATES THIS TO A REC.
18	BLDG 511	RESIDUAL PCB-CONTAMINATED CONCRETE AT CONCENTRATIONS WHICH ARE CLASSIFIED AS TSCA 'RESTRICTED AREA' (FORMER TRANSFORMER SUBSTATION 10, BLDG 511) REMAINS IN-PLACE. AT THE TIME OF THE SHAW NOVEMBER 2011 SITE RECONNAISSANCE OIL STAINING WAS OBSERVED ON THREE EXISTING METAL BASE-PLATES (FORMER TRANSFORMER LOCATIONS) AND SURROUNDING CONCRETE. NO ENCAPSULATING GREY EPOXY PAINT WAS OBSERVED.

19	BLDG 511	RESIDUAL PCB-CONTAMINATED SOIL ABOVE ILLINOIS TACO TIER 1 COMMERCIAL/INDUSTRIAL INGESTION REMEDIAL OBJECTIVE REMAINS IN-PLACE (TETRA TECH 2004, SB-04) BENEATH BLDG 511. THE EXISTING CONCRETE FLOOR SLAB HAS BECOME AN 'ENGINEERING BARRIER' RELATIVE TO THE RESIDUAL PCB-CONTAMINATED SOIL.
20	BLDG 920	DURING THE WESTON INITIAL OVER-EXCAVATION AND SOIL REMOVAL ACTIVITIES ASSOCIATED WITH BLDG 920, FREE PRODUCT MIGRATED INTO THE SOUTHWESTERN CORNER OF THE EXCAVATION, ENTERING FROM A WESTERLY DIRECTION (THE DIRECTION OF BLDG 914). A CLAY BERM WAS CONSTRUCTED TO MINIMIZE MIGRATION OF FREE PRODUCT INTO EXCAVATION. UTILIZING AVAILABLE BORING LOGS (BORING LOGS WERE NOT AVAILABLE FOR WESTON 2006 NEARBY BORINGS - B-1 TO B-5 AND B-218 TO B-19) A FREE PRODUCT PLUME MAY REMAIN IN-PLACE AND EXTEND IN A WEST AND NORTHWESTERLY DIRECTION UP TO POTENTIAL DISTANCES OF 125 FT (THE NEXT CLOSEST AND AVAILABLE BORING LOG RECORD). IT SHOULD BE NOTED THAT TWO RELATIVELY LARGE FUEL OIL USTS WERE ILLUSTRATED ON THE 1911 SANBORN FIRE INSURANCE MAP, NORTHWEST OF BLDG 920. A SECONDARY OVER-EXCAVATION AND SOIL REMOVAL ACTIVITY WAS COMPLETED; THE DIMENSIONS AND EXTENTS WERE NOT SPECIFIED. THERE IS A LACK OF QUALITATIVE SOIL AND/OR GROUNDWATER DATA IN THIS GENERAL AREA VALIDATING AND SUBSTANTIATING THE APPROPRIATE REMOVAL OF CONTAMINATED SOIL. FURTHERMORE, THE QUALITATIVE NATURE, HORIZONTAL AND VERTICAL EXTENT OF THE LIKELY REMAINING FREE PRODUCT PLUME NEAR BLDG 920 HAS NOT YET BEEN FULLY DEFINED.

21	BLDG 714	RESIDUAL PCB-CONTAMINATED CONCRETE AT CONCENTRATIONS WHICH ARE SUBJECT TO TSCA REGULATIONS (FORMER TRANSFORMER SUBSTATION 6, BLDG 714) REMAINS IN-PLACE.
22	BLDG 715 EXTERIOR TO NORTH	THE 1939 - 2004 SANBORN FIRE INSURANCE MAPS ILLUSTRATE THE PRESENCE OF A 'WOODEN DUST TANK' SITUATED NORTH OF BLDG 715. THE COMPOSITION OF THE DUST (METAL, WOOD OR ASH) STORED WITHIN THIS TANK IS UNKNOWN. BASED ON SHAW'S EXPERIENCE WITH THESE OPERATIONAL AREAS PETROLEUM AND/OR HAZARDOUS SUBSTANCES (LIQUID/OIL/MIXTURE MISTS AS A DUST CONTROL MECHANISM, METAL DUST PARTICLES CONTAMINATED WITH CUTTING OIL OR DIPPING CHEMICALS APPLIED PRIOR TO MACHINING), CAN BE ASSOCIATED WITH THIS DUST COLLECTION AREA. THERE IS A LACK OF QUALITATIVE SOIL AND/OR GROUNDWATER DATA AVAILABLE WITHIN THIS GENERAL AREA (NORTH OF BLDG 715) WITH RESPECT TO PCB, VOC, AND CVOC CONSTITUENTS.
23	BLDG 615	RESIDUAL PCB-CONTAMINATED CONCRETE AT CONCENTRATIONS WHICH ARE CLASSIFIED AS TSCA 'UNRESTRICTED AREA' (FORMER TRANSFORMER SUBSTATION 7, BLDG 615) REMAINS IN-PLACE.

24	BLDG 811	RESIDUAL PCB-CONTAMINATED SOIL ABOVE ILLINOIS TACO TIER 1 COMMERCIAL/INDUSTRIAL INGESTION REMEDIAL OBJECTIVE REMAINS IN PLACE (TETRA TECH 2004, SB-02/TMW-1) IMMEDIATELY WEST OF BLDG 811.
25	BLDG 913	THE 1939 - 2004 SANBORN FIRE INSURANCE MAPS ILLUSTRATE THE PRESENCE OF 'PICKLING' OPERATIONS IN BLDG 913. BASED ON SHAW'S EXPERIENCE WITH THESE OPERATIONAL AREAS HAZARDOUS SUBSTANCES (HYDROCHLORIC ACID, SULFURIC ACID, AND SOLVENTS WITH VOCs/CVOCs) ARE TYPICALLY USED. THERE IS A LACK OF QUALITATIVE SOIL AND/OR GROUNDWATER DATA AVAILABLE WITHIN THIS GENERAL AREA (BLDG 913) WITH RESPECT TO ACIDIC CONDITIONS, VOC, CVOC CONSTITUENTS; SAMPLES COLLECTED IN THE PAST HAVE BEEN ANALYZED FOR METALS.
26	BLDG 916	RESIDUAL PCB-CONTAMINATED CONCRETE AT CONCENTRATIONS WHICH ARE SUBJECT TO TSCA REGULATIONS (FORMER TRANSFORMER SUBSTATION 5, BLDG 916) REMAINS IN-PLACE.
27	BLDG 914 EXTERIOR TO EAST	THE 1911 SANBORN FIRE INSURANCE MAP ILLUSTRATES THE PRESENCE OF TWO LARGE FUEL OIL USTS LOCATED EAST OF BLDG 914. IT IS UNKNOWN IF THESE USTS REMAIN IN-PLACE. THERE IS A LACK OF QUALITATIVE SOIL AND/OR GROUNDWATER DATA AVAILABLE WITHIN THIS GENERAL AREA (EAST OF BLDG 914) WITH RESPECT TO THIS UST AREA.
